Right Ventricular Myocardial Perforation by Pacemaker Lead

Syrine Dardour.¹; Souha Friha.¹; Ganzoui²; Hedi Ben Slima¹

1. *Cardiology Department, Menzel Bourguiba Hospital*
2. *Radiology Department, Habib Bourguiba Hospital*

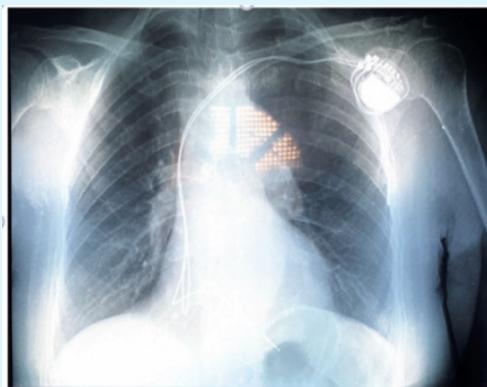
We report the case of a 67-year-old woman diagnosed in April 2024 with complete atrioventricular (AV) block, for which she underwent implantation of a dual-chamber pacemaker. Immediate post-implantation chest radiography confirmed appropriate positioning of the pacing leads. (figure 1)

Figure 1. Chest radiography post implantation: pacing leads in place without a visualized perforation

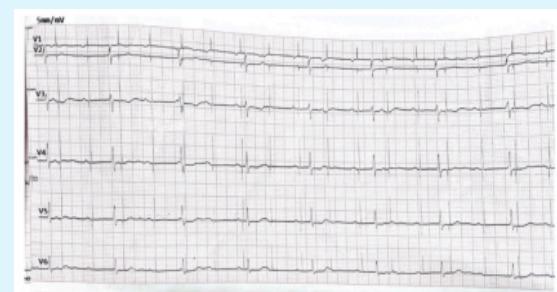
One month later, the patient presented to our cardiology department with abdominal pain. Her blood pressure was 110/80 mmHg and her heart rate 60 bpm, with no signs of shock or right-sided heart failure. The electrocardiogram (EKG) showed loss of capture and inappropriate stimulation, with pacemaker spikes occurring within the QRS complexes (Figure 2).

Figure 2. EKG Loss of capture and inappropriate stimulation.

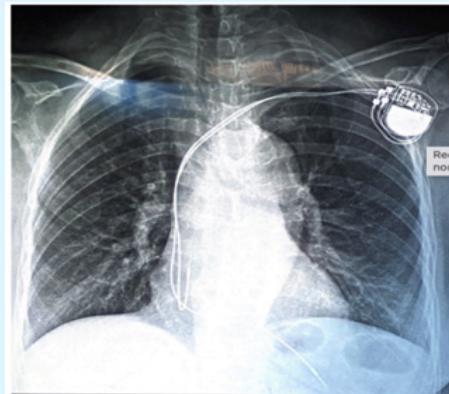
A chest radiograph revealed downward displacement of the ventricular pacing lead, projecting below the left diaphragmatic shadow. Lead migration was suspected.(Figure 3).

Figure 3. Chest radiograph Revels displacement of the ventricular pacing lead

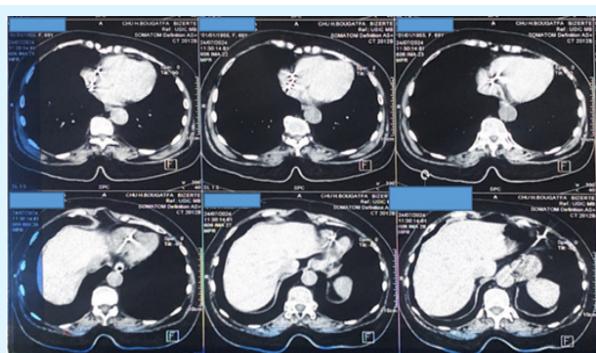
A subsequent CT scan confirmed right ventricular perforation by the pacing lead. The lead tip was found outside the myocardium, in contact with the parietal pericardium and embedded in the epicardial fat layer. No pleural or pericardial effusion was detected (Figure 4).

Figure 4. CT scan with right ventricular perforation by the pacing lead

Given the patient's hemodynamic stability, a conservative management strategy was adopted. The ventricular lead was removed by transvenous extraction under fluoroscopic guidance in the catheterization laboratory using simple traction, and was then repositioned in the appropriate right ventricular location. This was achieved without resorting to cardiac surgery, which was kept as a bailout option, and with the cardiac surgery team informed and ready to intervene in case of complications. The postoperative course was uneventful, and the patient was discharged three days later.
