Pectoral muscle contractions as a consequence of Twiddler's syndrome

E. Allouche, K. Sammoud, H. Bousaid, H. Sammoud, A. Chettoui, S. Sidhom, Nadia Hammami, L. Bezdah, W. Ouechtati, H. Baccar

Service de cardiologie, hôpital Charles Nicolle de Tunis,
Faculté de médecine de Tunis - Université de Tunis El Manar

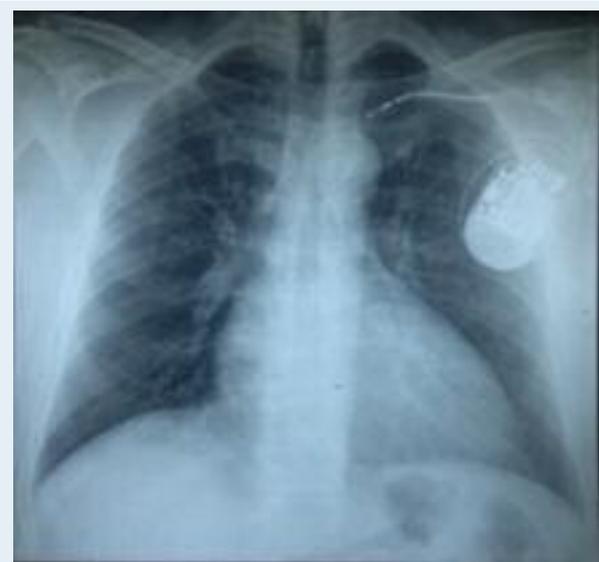
Figure 1 : Different severe VHD involvement in the study population

A chest X-ray was performed and showed that the generator had rotated and the right ventricular lead was excessively twisted around the device and its distal tip was situated in the left subclavian vein.

The right ventricular lead didn't sense ventricular activity which was interpreted as a cardiac pause by the ICD. Thereby, the device was delivering inappropriate stimulations causing pectoral contractions.

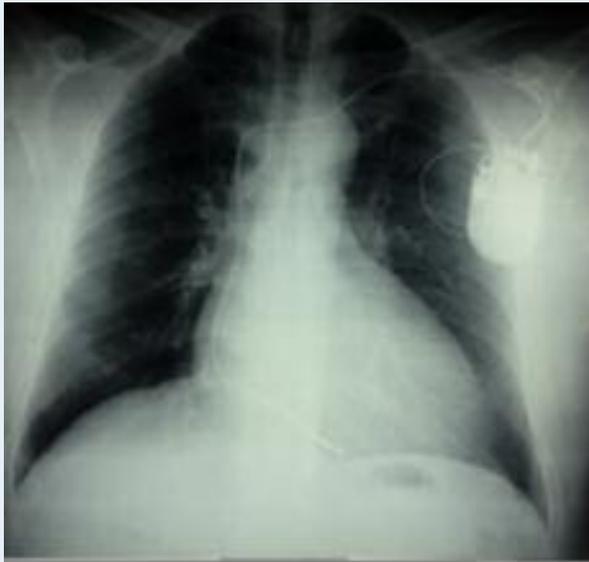
Figure 2 : after right lead replacement

The device was rapidly turned off and then we underwent a replacement of the right ventricle lead which was not damaged.
